Loyd Ray Farms: Best Practices Guide

This document aims to entail the “lessons learned” at Loyd Ray Farms (LRF), an innovative swine waste-to-energy system at an 8,640 feeder-to-finish farm in western North Carolina. The project began in 2011 as a partnership between Duke University, Duke Energy, and Google, Inc., to produce carbon offsets and Renewable Energy Credits (RECs) and meet North Carolina’s Innovative Swine Waste Management Permit using an anaerobic digestion and aeration system. The project is led by Duke University’s Carbon Offsets Initiative (DCOI) and managed by Cavanaugh and Associates, P.A.

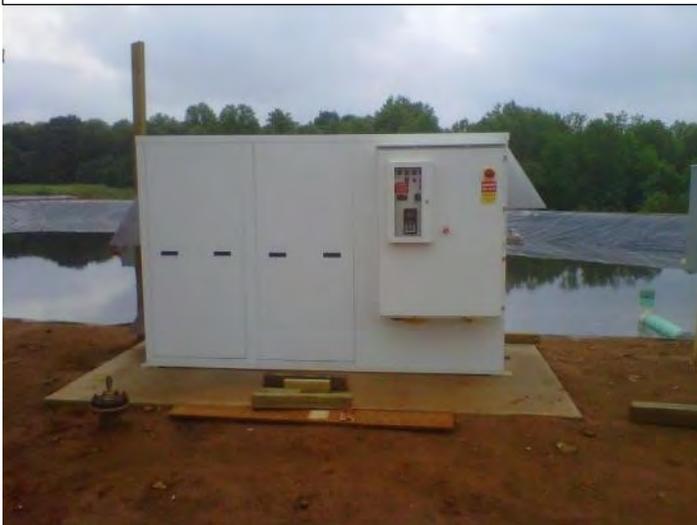
Before: The original smaller, unsuitable gas conditioning skid.

Because of the concentration of hydrogen sulfide and the high moisture associated with biogas production, the initial gas conditioning skid installed at LRF failed. The original skid could not handle the corrosive nature of the biogas, leading to multiple system failures. Because these system failures halted all biogas utilization, complete replacement was required and occurred over 6 months between 2012 and 2013. The original skid was replaced with an industrial-scale gas skid which came at a higher cost, but offered much greater reliability, as it was able to withstand the corrosivity of the biogas.

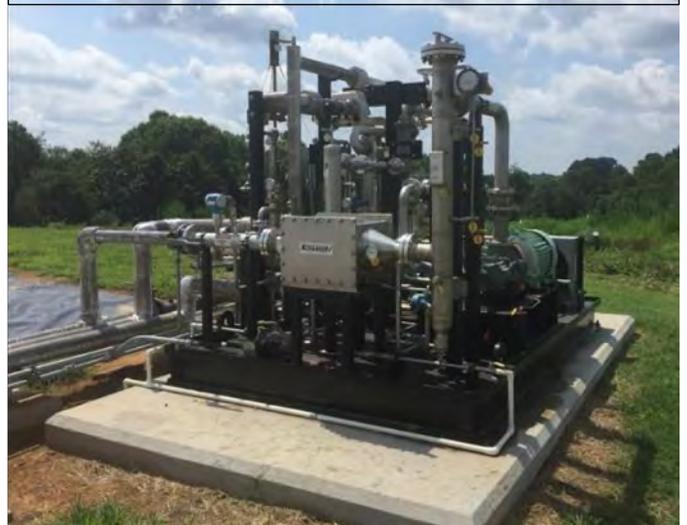
After: The new, industrial-scale gas conditioning skid at LRF

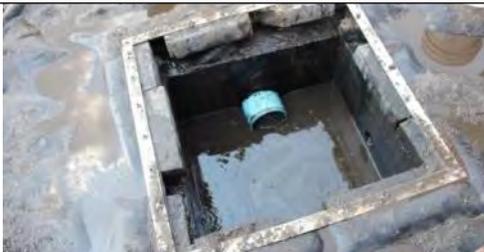
The Problem: The anaerobic digester liner was improperly installed with leaks located around the concrete sump for the mixing pumps, requiring replacement.

Before: The improperly installed synthetic liner.

A liner failure was discovered in April 2013. To determine the best replacement liner to meet the North Carolina standards for permeability, the project management team met with the Division of Water Resources (DWR). While North Carolina had typically required a plastic HPDE liner for newly constructed animal waste lagoons and digesters, the industry-wide failure rate associated with these plastic liners (~10%) led to the use of an innovative alternative. LRF, located in western North Carolina, contains predominantly clay soils. Clay soils have relatively low permeability by nature and can be augmented to reach permeability levels above and beyond the legal requirements by an order of magnitude. Thus, the clay soil was augmented with bentonite, limiting the permeability to less than 1×10^{-7} , surpassing the standards for groundwater contamination prevention set up by the Natural Resources Conservation Service (NRCS).

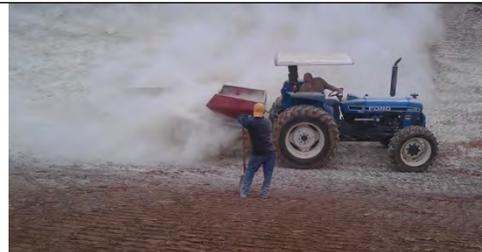
After: Bentonite being applied.

The augmentation was completed by applying bentonite to the digester at a 1.25-centimeter depth, and then tilling the Bentonite into the clay soils with an agricultural tiller. Once the bentonite was applied and sufficiently incorporated into the clay soils, the permeability was tested and confirmed to meet the required NRCS standard of 1×10^{-6} . While this case represented an exception from the traditional HPDE liners recommended by the DWR, it proved sufficient given the geological characteristics of LRF.

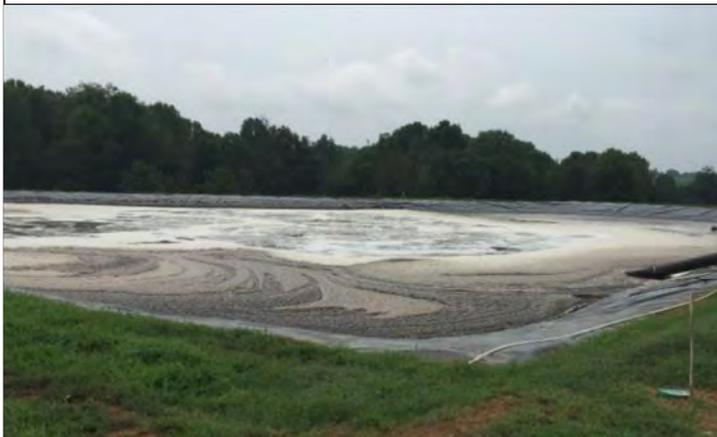
The Problem: Sludge build-up in the digester and aeration basin over time.

Before: Some sludge accumulation in the aeration basin at LRF.

Upon recognition of the liner failure mentioned above, the digester was drained to determine the location of the issue and repair the problem. This act combined with regular flushing and the volume of the digester has limited the need for sludge removal. Periodically, some of the sludge from the aeration basin has been pumped back to the anaerobic digester to keep the total solids concentration around 1% in the aeration basin and to promote biogas production.

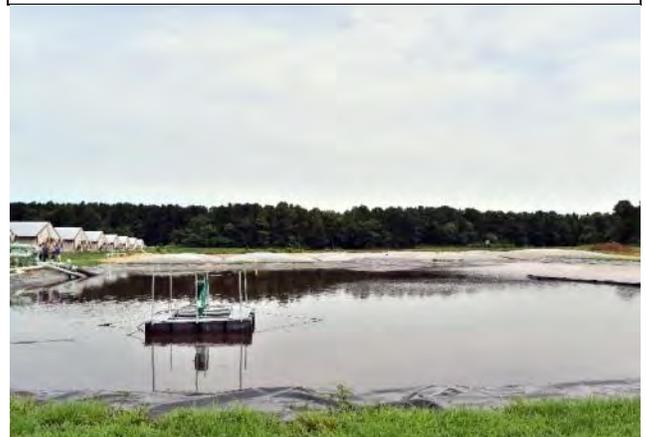
After: Very little sludge accumulation in the basin

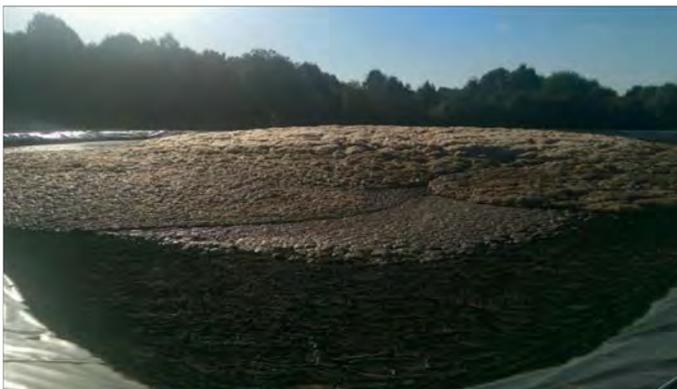
During aeration of the aeration basin, foaming is sometimes observed. While the foaming is not detrimental to any part of the system's processes, it does violate the innovative permit should foam leave the aeration basin. The liquid volume of the basin varies naturally given system function and rainfall, and upon higher-than-normal volumes within the basin, foaming can become an issue. The foaming process is not completely understood, but thought to be the result of a few factors including: phosphate levels in the liquid, high solids, overgrowth of filamentous bacterial, a high C/N ratio, or an undesirable pH.

Before: High foam levels in the aeration basin.

To limit the concern associated with aeration basin foaming, the aeration process was reduced in duration until improvements were observed. Thus far, limiting the time associated with the aeration process and regular solids removal to the digester has proven a sufficient process for reducing foaming without hindering system function. In addition, cameras were installed on site so the system could be observed remotely, especially during times when the aeration basin had high levels.

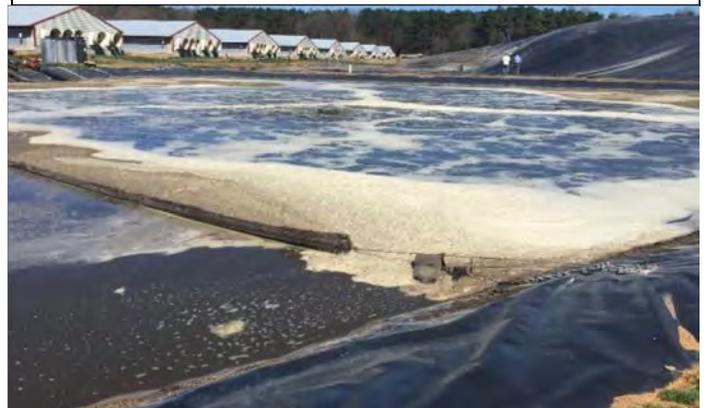
After: Normal and controlled foam levels in the aeration basin.

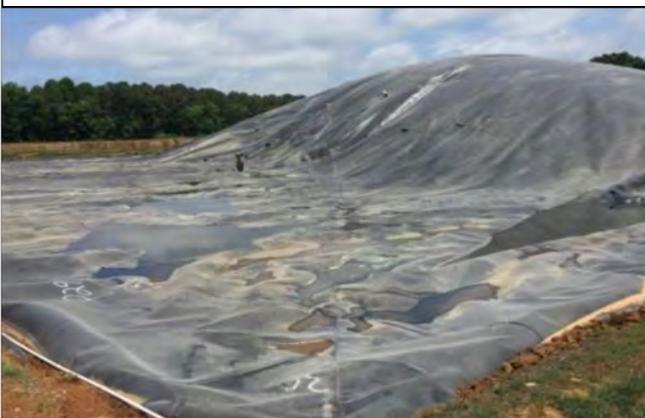
Throughout the early months of 2015, the anaerobic digester cover exhibited several holes and tears. While a short-term solution involved using adhesives and welding, the recurrence of the issue meant more needed to be done. The tears and holes were not easy to locate across the large surface area of the cover, and required smelling for methane. Given this difficulty, DCOI and LRF decided to replace the cover.

The cover exhibiting tears and holes was the second cover used at LRF. Using a different contractor than the one associated with the original cover, the second cover was installed “dry”, when the digester was empty, resulting in excess cover material. This extra material allowed for the digester cover to “balloon” and store gas, but caused problems during heavy rains or low biogas conditions in the digester as the excess material folded, creased, and pinched to produce fissures, tears, and holes.

Before: The second cover at LRF that exhibited issues.

The third cover, recently completed in mid-2017, more closely resembles the original cover. It involves a system of pipes and weights to limit the ballooning height and reduced the total amount of cover surface area. In addition, the anchor trench was dug deeper to support some gas storage.

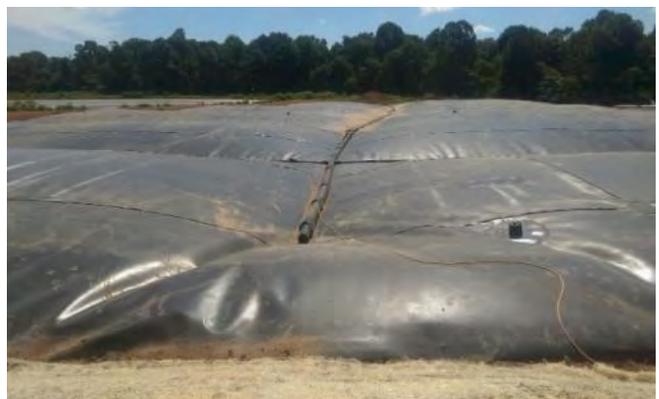
After: The new, better fitting cover at LRF.
